Manhole Inspection Summary

Manhole # S47I2_003MH

Insp Date: **1/10/08 1:42 PM**

Location Address: **4731 Pennington Ave**

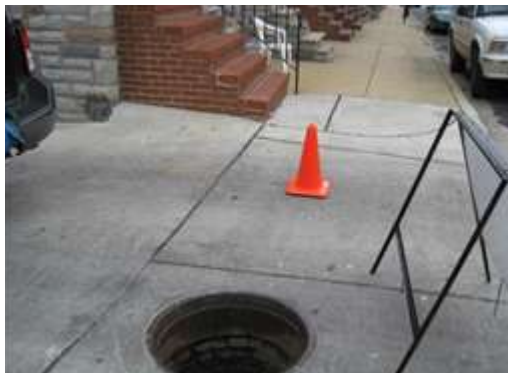
Location View

Pennington Alley & Church St

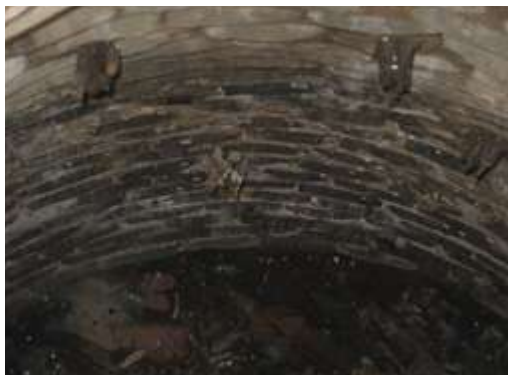
Defect 2

Steps Count: **0** Missing: **3** ☐ Corroded

steps

steps missing/broken off

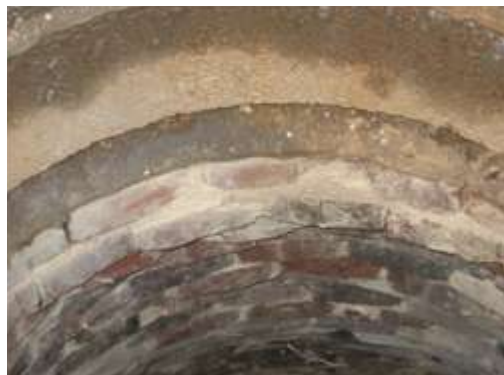
Defect 1

Frame Offset: **2** (in.) Condition: ☒ Sound ☐ Cracked ☐ Leaks

frame offset

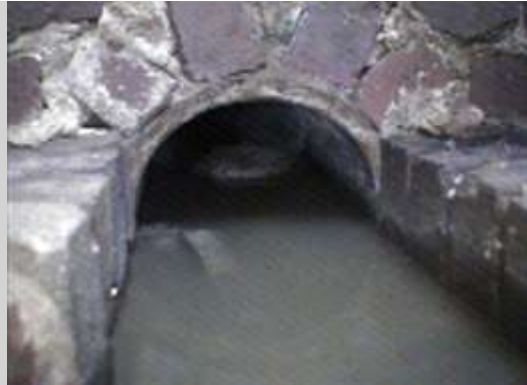
12 O'Clock Outflow

8 in. Circular Gravity Sewer
Pipe Out @ 12 O'Clock

Pipe Height: **10.8** (in.) Rod and Bar (Angled)
Pipe Material: **Clay** ☐ Pipe Lined
Invert Depth: **7.72** (ft.) Flow Characteristics: **Slow**
Deposits: ☒ None ☐ Mud ☐ Sludge ☐ Debris ☐ Grease
Silt Depth: (in.) Deposits Extent:
Infiltration: **None** Pipe Seal Cond: **Sound**

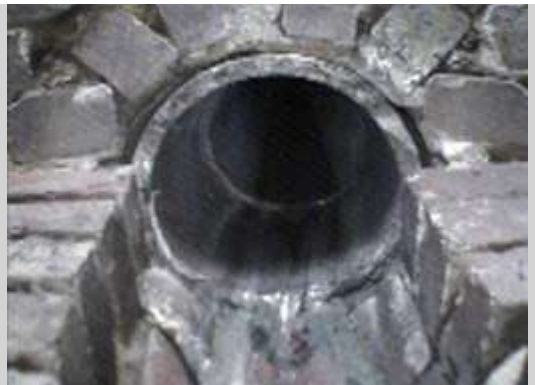
9 O'Clock Inflow

8 in. Circular Gravity Sewer
Pipe In @ 9 O'Clock

Pipe Height: **9.6** (in.) Rod and Bar (Angled)
Pipe Material: **Clay** ☐ Pipe Lined
Invert Depth: **7.16** (ft.) Flow Characteristics: **Slow**
Deposits: ☒ None ☐ Mud ☐ Sludge ☐ Debris ☐ Grease
Silt Depth: (in.) Deposits Extent:
Infiltration: **None** Pipe Seal Cond: **Sound**
